## Silicon Precipitate Nodule-Induced Failures of MOSFETs

M. Johnson and D. Pote  
Motorola, Inc.  
Northbrook, IL

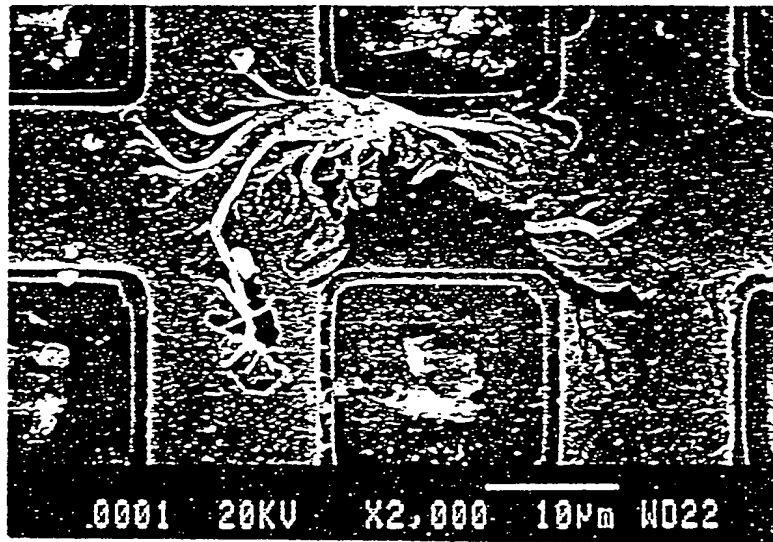
Figure 1: Unique pattern of fused polysilicon observed after removal of metallization and insulating oxide. (2000X)

Subsequent optical inspection identified an apparent electrical damage site under the wirebond. This damage was characterized by a central fused-site surrounded by multiple filaments (Figure 1). These filaments were dubbed "tentacles" or "roadkill" damage because of their appearance. SEM inspection of the same locations revealed surprisingly little

It is now believed that the filaments are the result of amplification of the damage at the original failure sites by the application of excess power during liquid crystal testing. A slightly higher level of power was necessary to counteract the obstructing heatsink effect of the relatively large wirebond. The heat generated at the damage site would initiate crystallization of the amorphous polysilicon depend-

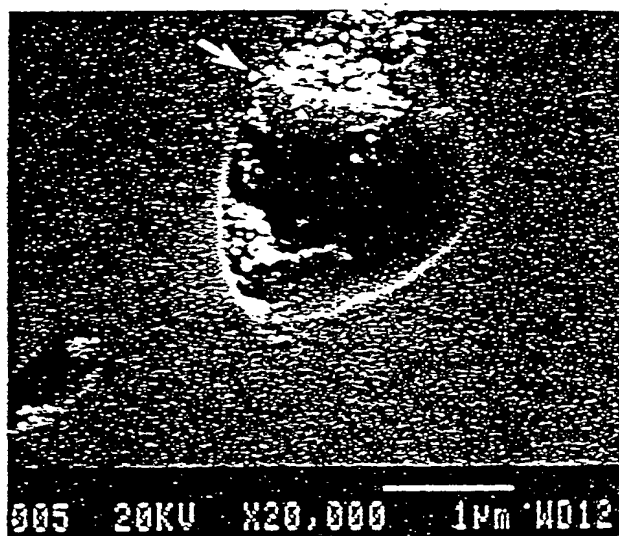
Figure 2: Small electrical damage site within chipet.  
(25000X)

Cross-sections of failures revealed that the filaments were confined to the polysilicon layer, except at the central nucleus. At the nucleus, melted silicon and aluminum were observed extending vertically through the dielectric layer. On several devices where the filamentation was minimal, there was limited evidence of melting at the nucleus site and a small section or chip of the dielectric was missing (figure 2).

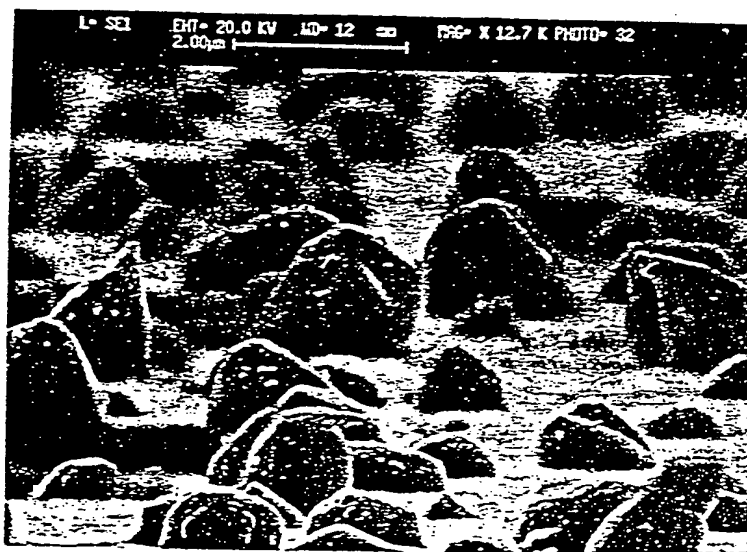
Figure 3: Silicon precipitates (nodules) viewed from side exhibit variety of shapes and sizes. (12700X)

shape. Although they appear roughly circular under high power microscopy (400X), they are actually polyhedral and exhibit a wide range of aspect ratios (Figure 3). Typical height/width ratios range from 0.3 to 1.8.

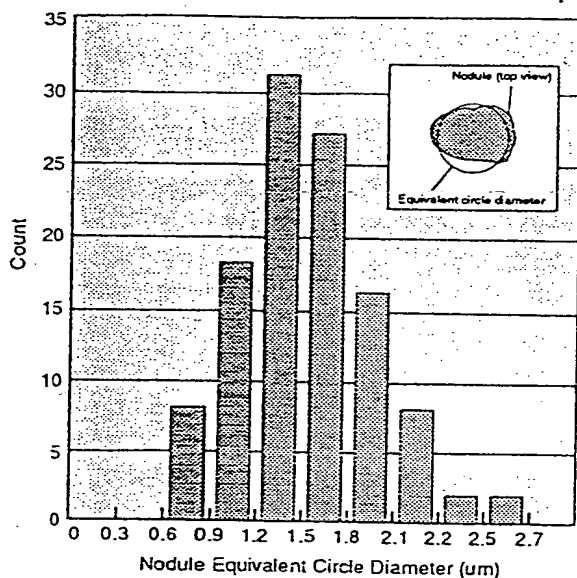
There were typically  $50 \times 10^3$  to  $100 \times 10^3$  nodules per square millimeter in the subject devices. In general, the nodule density -- the number of nodules per unit surface area -- was inversely proportionate to the average size of the nodules. That is, when the nodules were large, there tended to be few of them. Conversely, when the nodule count was high, they tended to be small. Figure 4 shows a typical histogram of nodule sizes produced by an image analysis

Figure 4: Example distribution of nodule sizes

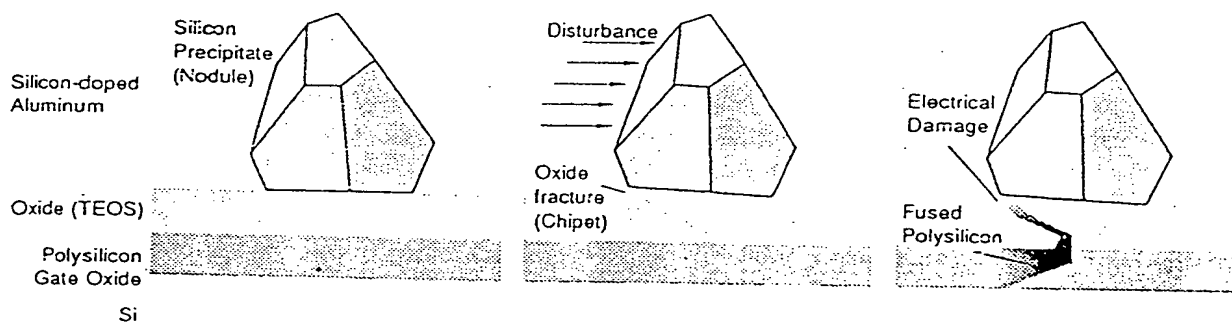
The adhered nodules could be removed quite easily; gentle brushing of a few fibers from a cotton swab was sufficient to disturb them. When these well-adhered nodules are displaced, they often take with them a portion of underlying oxide, forming a distinctive, football-shaped chip-out, or *chipet* (Figure 5). The depth of the resulting chipet was roughly equal to half the length of the chipet's minor axis, itself related to the area of contact between nodule and oxide.

In the MOSFET devices the lateral displacement of the nodules occurs during the wirebonding process. The cavity formed by the chipet is immediately filled with aluminum. These chipets, during

Figure 5: Movement of nodule results in fracture of underlying oxide.

electrical stress, appear to act as weak points in the insulating oxide. If the chiplet is sufficiently deep to fully compromise the thickness of the dielectric oxide, a linear resistive short between the source metallization and gate polysilicon results. However, if the root only partially compromises the dielectric, a leaky diode-like characteristic results.
